National Dam Inspection Program.
Hutchinson Reservoir Dam Number 2
(NDI-PA-215), Ohio River Basin, Redstone
Creek, Fayette County, Pennsylvania.
Phase I Inspection Report.

PHASE I INSPECTION REPORT
NATIONAL DAM INSPECTION PROGRAM

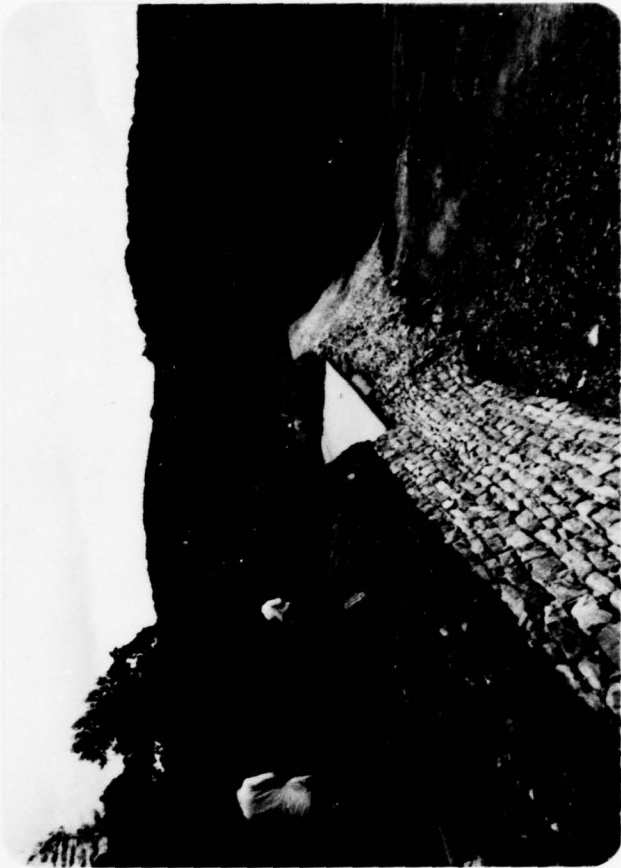
As indicated in Photograph 4, the main embankment section to the right of the spillway appears arched in the downstream direction. A drawing dated August 1914 (see Figure 3) depicts the embankment as indeed being somewhat parabolic in plan. However, since the drawing was made in 1914 or 11 years after construction, it is likely that it is a representation of existing conditions rather than the original design.

2. Spillway. The visual inspection found the spillway to be in good condition. No significant evidence of concrete deterioration was found in the main channel section which includes the approach section, control section, and downstream tiered section (see Photographs 4 and 9).

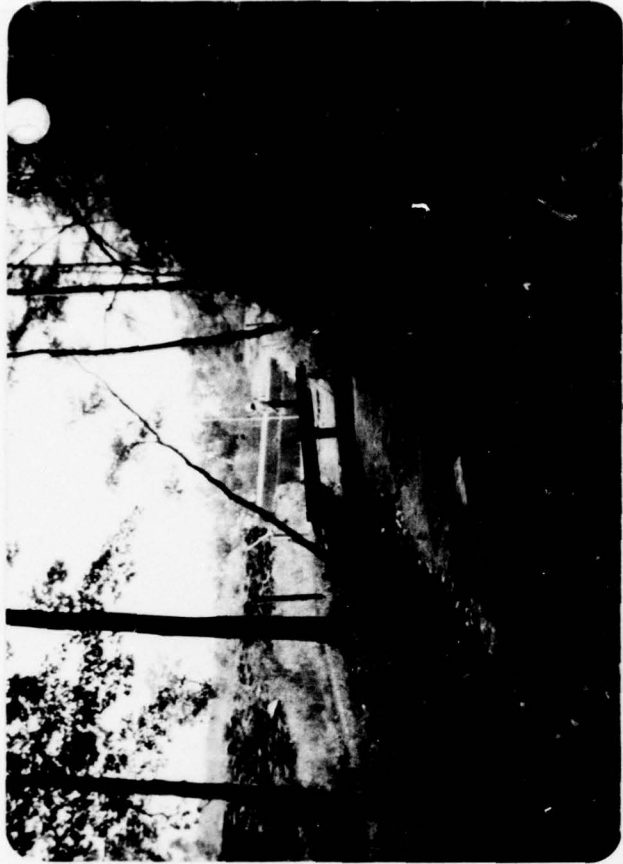
10

The floor of the smaller channel immediately downstream of the main channel section is extensively cracked; however, it appears to be firmly in place. The hand-placed rock sidewalls are well aligned, apparently sturdy, and in good condition (see Photograph 10).

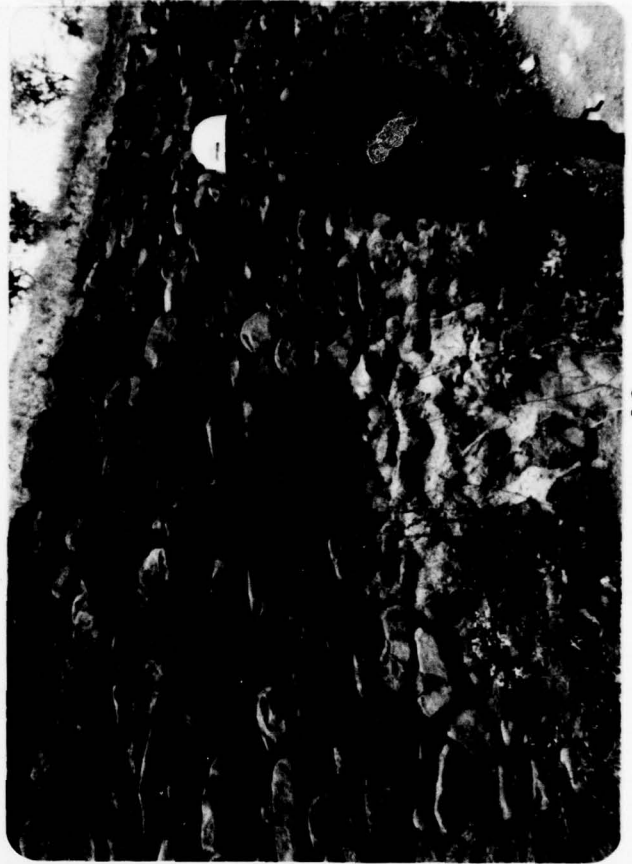
although highly irregular (see Photographs 2, and 3). An interesting area is located just above the access road near the center of the embankment. Here an oval shaped excavation was observed in the riprap face. The reason for this depression along with the evidence of grouting associated with it could not be determined (see Photograph 12).

PHOTOGRAPH 12 Disturbed area in downstream rock facing where apparent grouting was undertaken.

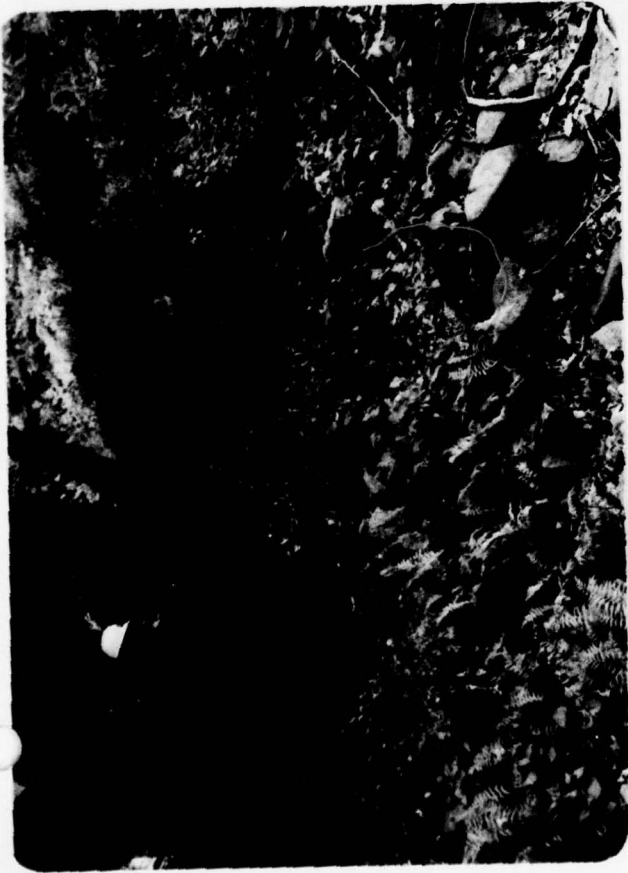
PHOTOGRAPH 13 View of the gate controls on the blowoff line (foreground) and supply line (background) located at the toe of the embankment.

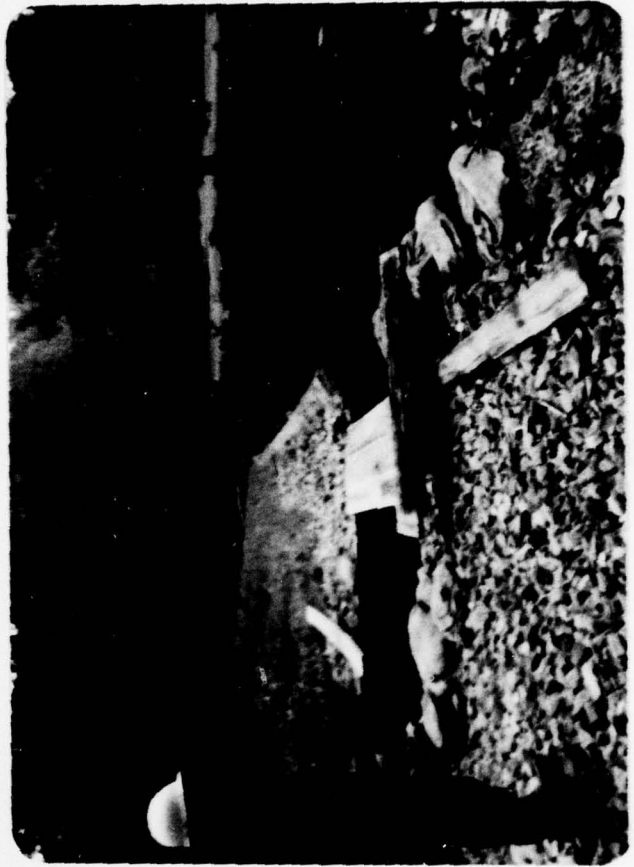
PHOTOGRAPH 14 View of a small pond located between Hutchinson Reservoirs Nos. 2 and 1. Using a system of pipes and flashboards, the owner can either direct water into Reservoir No. 2, via the channel in the foreground, or install flashboards in the foreground channel and divert water throughout the diversion ditch which passes around Reservoir No. 2.

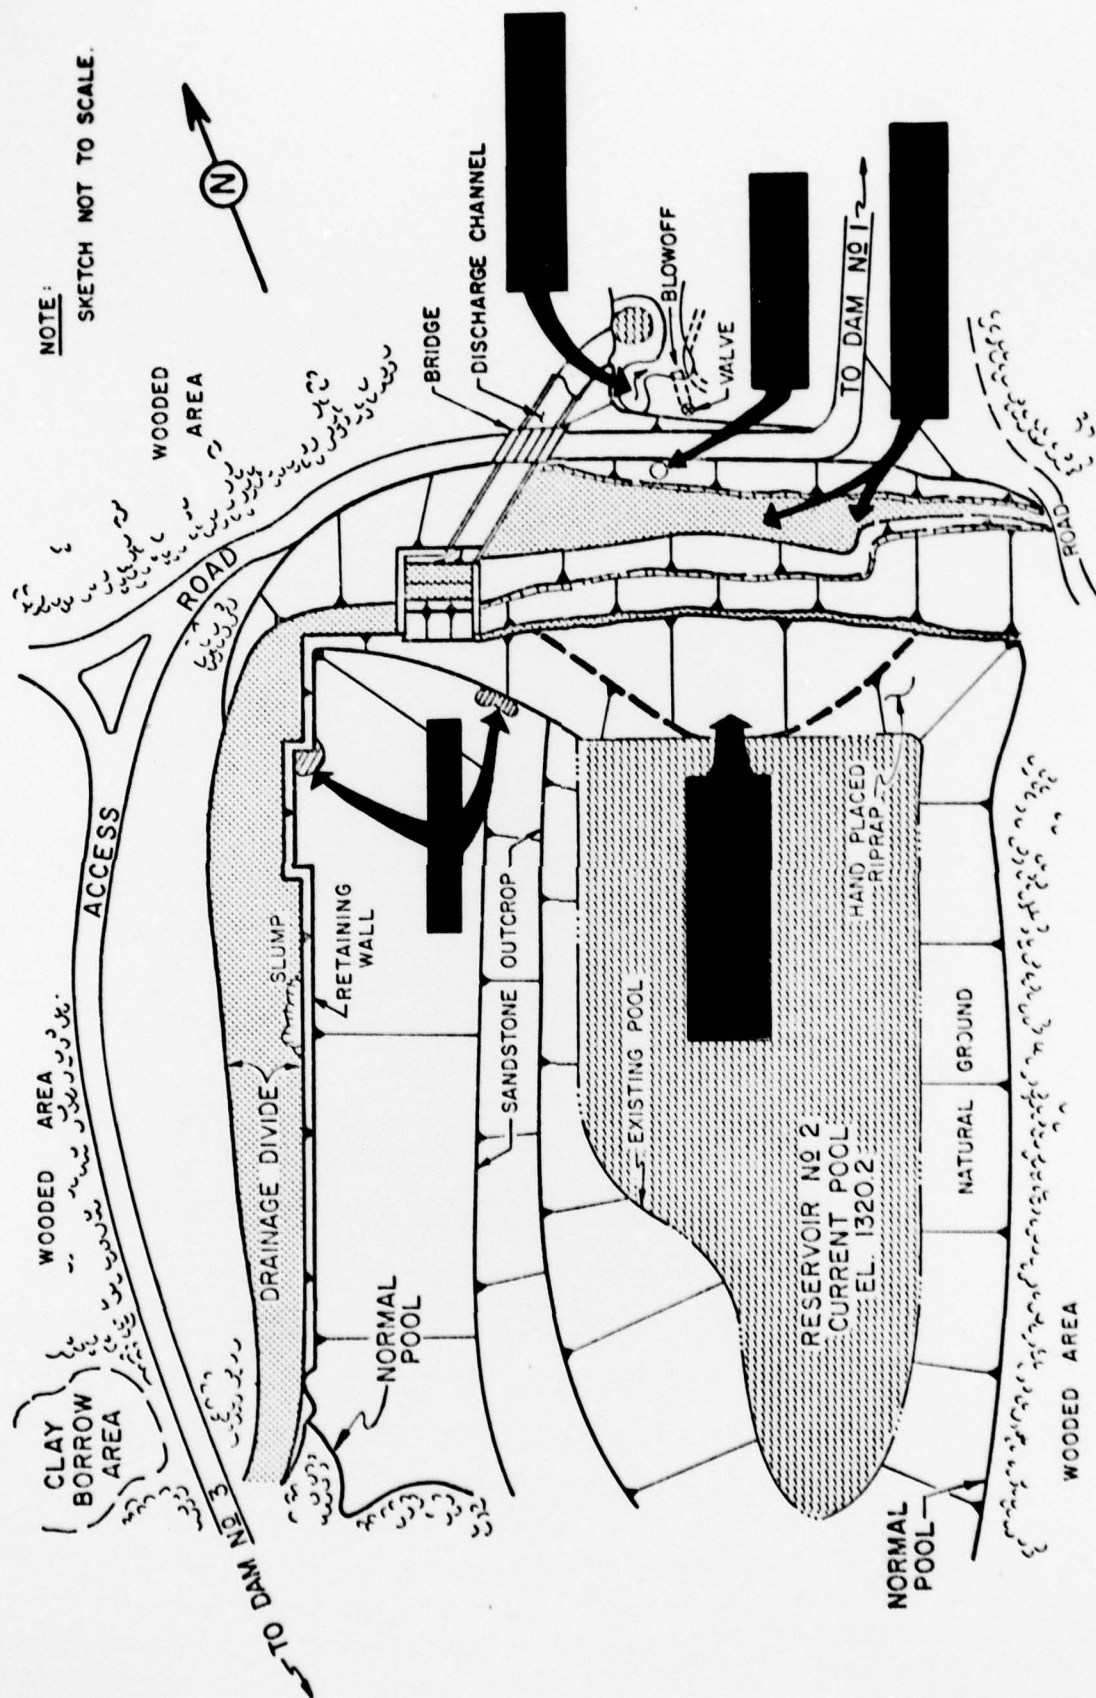
FIGURE 1 - HUTCHINSON RESERVOIR DAM NO. 2
GENERAL PLAN - FIELD INSPECTION NOTES

The embankment slopes, both upstream and downstream, exhibit an overall decrepitude. The field sketch (Figure 1) shows the approximate area of the upstream slope that appeared to be seriously bulged on the day of the inspection (see Photographs 4 & 6). Field measurements indicate that the upstream slope varies between 2H:1V at the abutments and 1H:1V at the bulged section. The present condition has possibly resulted from excessive drawdown rates. As indicated in Figure 1, the pool level at the time of inspection was at elevation 1320.2, about 15 feet below the spillway crest (reportedly as recently ordered by PennDER).
